Figure 3b (to FER-225). Ridgetop-spreading fissures produced during the 1989 Loma Prieta earthquake, and related geomorphic features associated with ridgetop spreading.

TABLE OF OBSERVATIONS - Figure 3b
(modified from Hart and others, 1990)

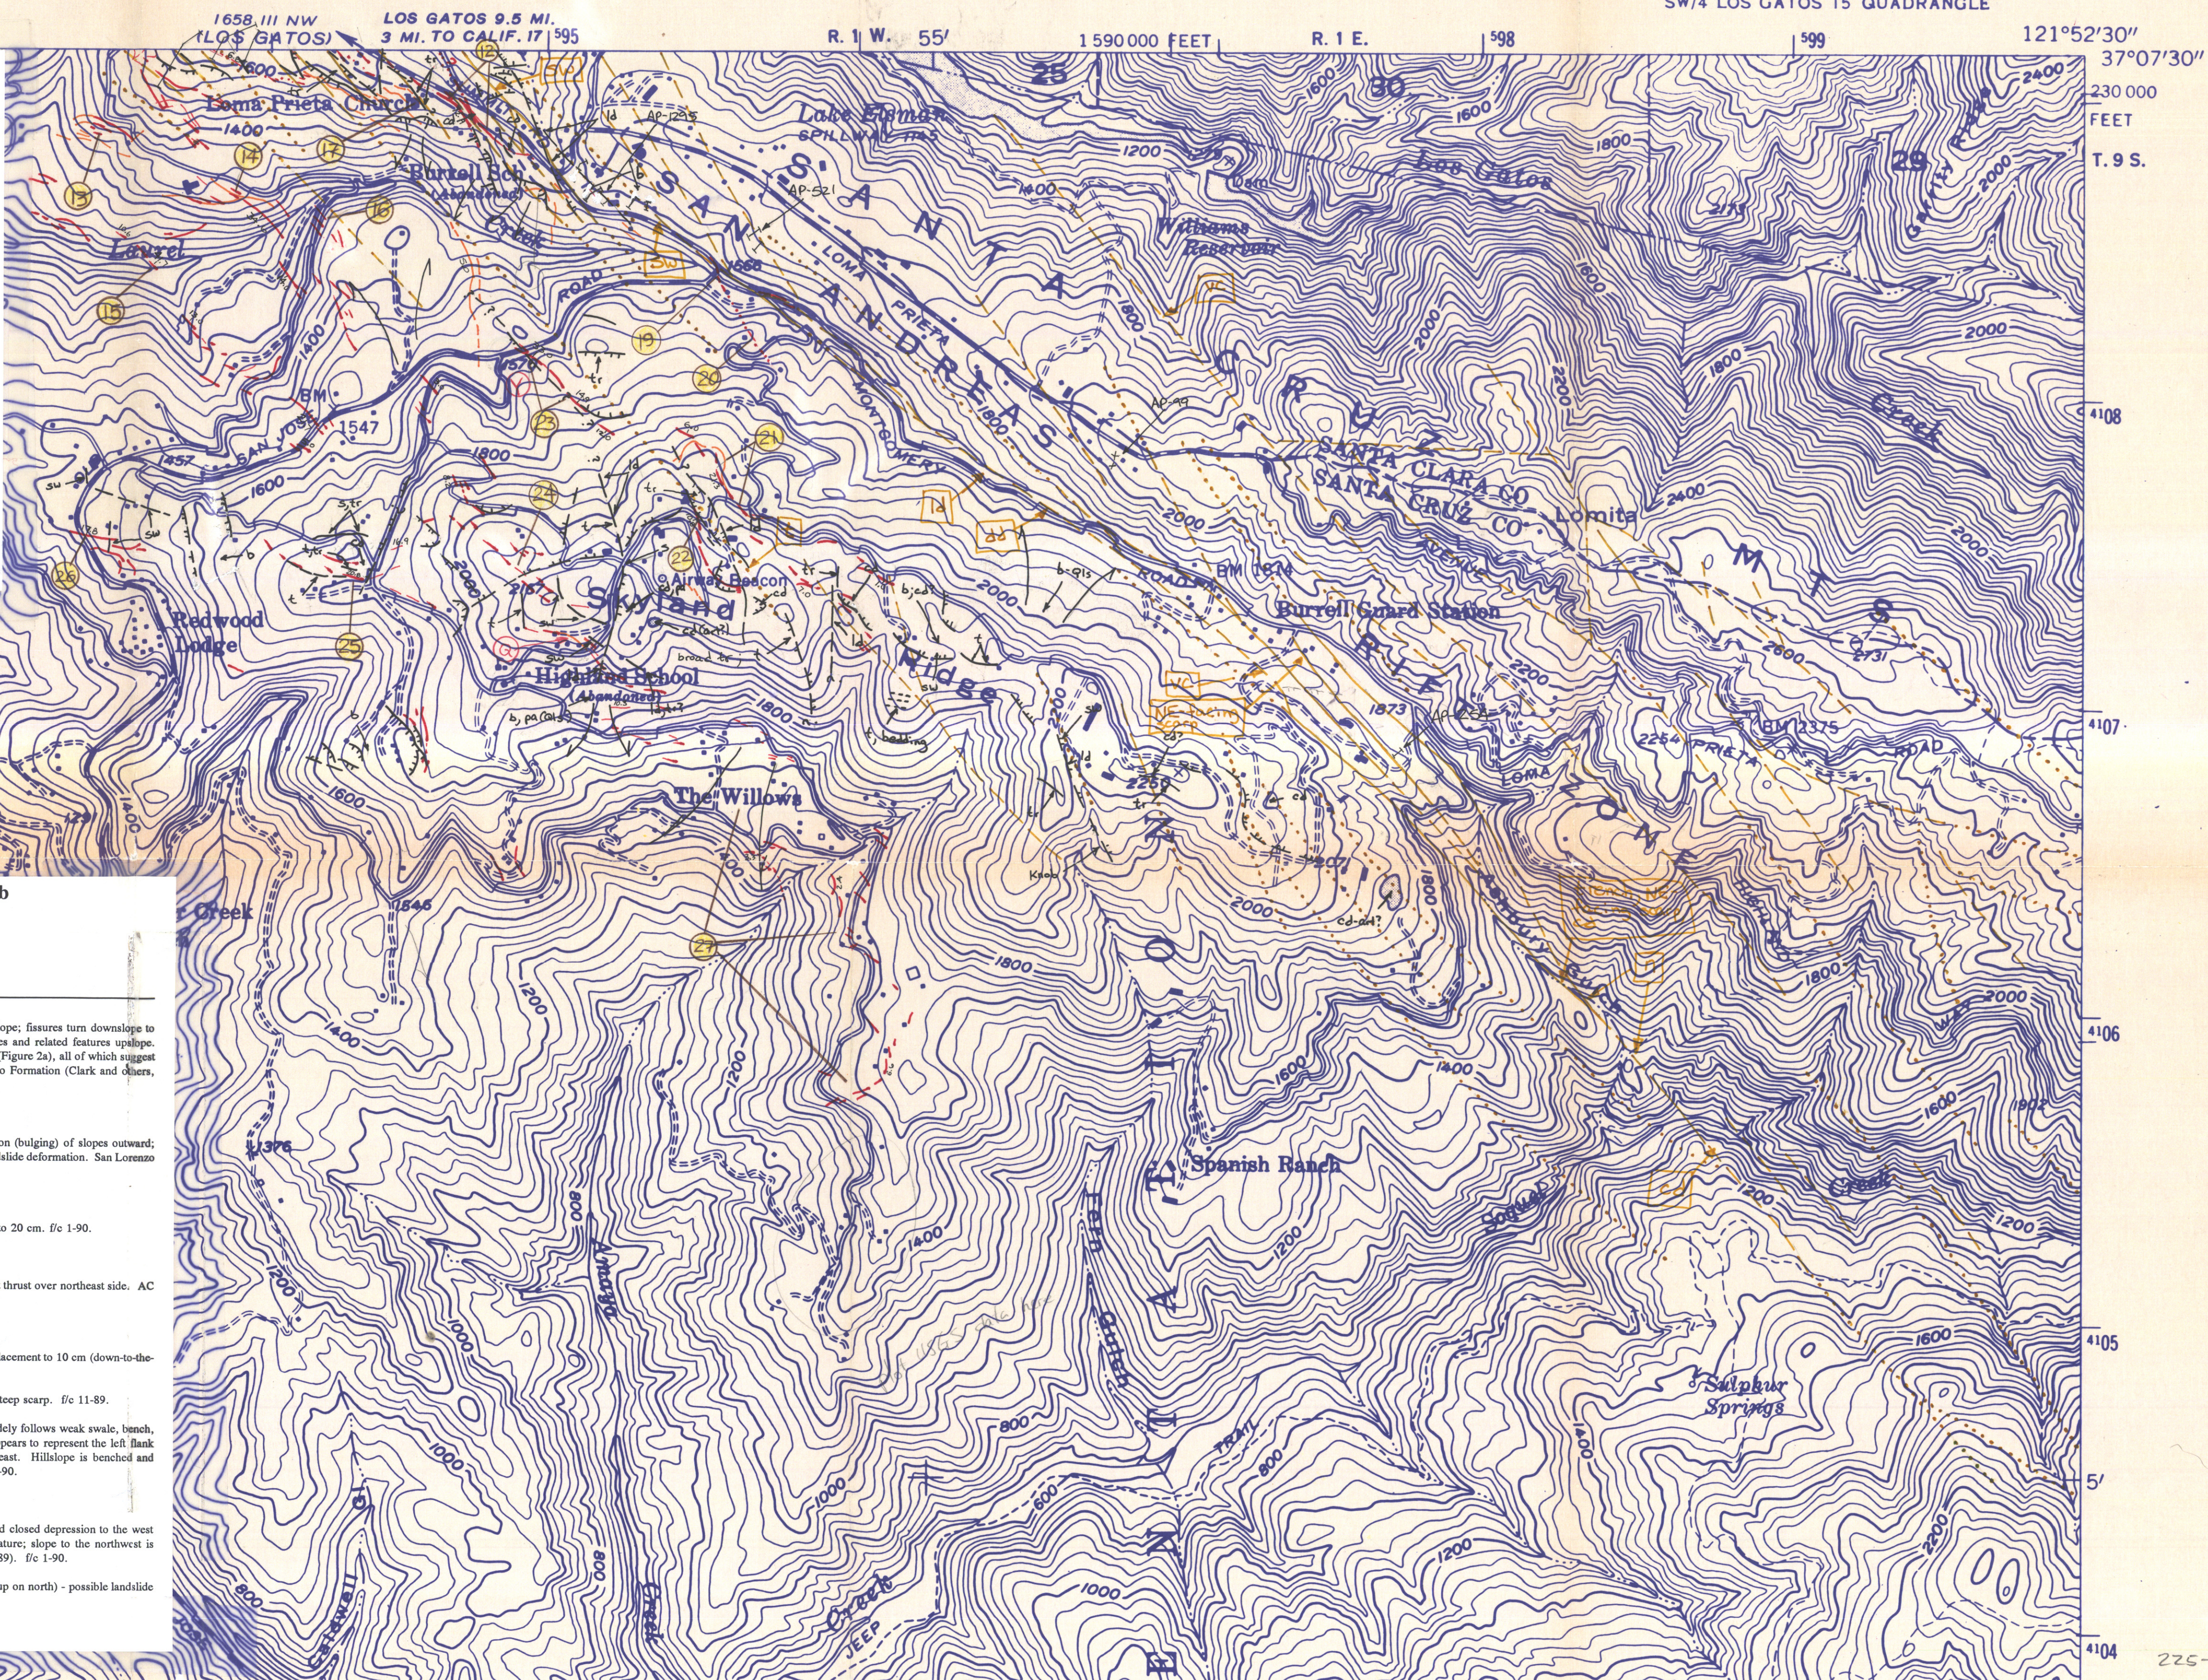
Locality	Description
13	Large extensional fissures with northeast-facing scarps developed on hillslope; fissures turn downslope to the west in benched topography; to east fissures connect landslide fissures and related features upslope. Fissures are gradational with those at C.T. English School farther upslope (Figure 2a), all of which suggest toppling associated with landsliding. In landslide deposits in San Lorenzo Formation (Clark and others, 1989). f/c 1-90.
14	Slump scarps. f/c 1-90.
15	Extensional cracks in sandstone outcrop in Laurel Creek suggest expansion (bulging) of slopes outward; bedrock is pervasively sheared and bedding attitudes erratic, suggesting landslide deformation. San Lorenzo Formation of Clark and others,(1989). f/c 1-90.
16	Minor fissures. f/c 1-90.
17	N55°W-trending cracks fissures damaged church. Extensional opening 8 to 20 cm. f/c 1-90.
18	Swaley ridge. f/c 1-90.
19	Northwest-trending zone of compressional cracks with southwest pavement thrust over northeast side. AC curbs are overturned. Cracks occur in fill. f/c 10-89.

20	Minor cracks, no pre-existing geomorphic expression. f/c 1-90.
21	Large extension cracks (to 46 cm) at head of landslide scarp. Vertical displacement to 10 cm (down-to-the-northeast). f/c 11-89.
22	23 cm-high scarp across AC-paved road extends northwest along base of steep scarp. f/c 11-89.
23	Large fissure zone extends diagonally uphill; 33 cm extension at road; crudely follows weak swale, bench, and scarps; left-lateral slip in eastern segment (Wells and others, 1989) appears to represent the left flank of a large landslide as do other crack zones to the northwest and southeast. Hillslope is benched and hummocky. Butano shale and sandstone of Clark and others (1989). f/c 1-90.
24	No geomorphic expression except broad ridgeline. f/c 1-90.
25	Fissures with 21 cm of extension at road coincide with a broad trough and closed depression to the west which, along with arcuate pattern of fissure zone, indicate a landslide feature; slope to the northwest is benched and hummocky. San Lorenzo Formation of Clark and others (1989). f/c 1-90.

26	Fractures with extensional openings to 15 cm and scarp up to 15 cm high (up on north) - possible landslide headscarp. No geomorphic evidence associated with fractures. f/c 1-90.
27	Arcuate fissures on benched slopes indicate landslides. f/c 1-90.
